The Citagenix Clinical Report

Issue 6

Immediate Implant Placement and Sinus Lift with Simultaneous Guided Bone Regeneration

Dr. William F. Runyon, Jr., D.D.S., Ft. Worth, TX

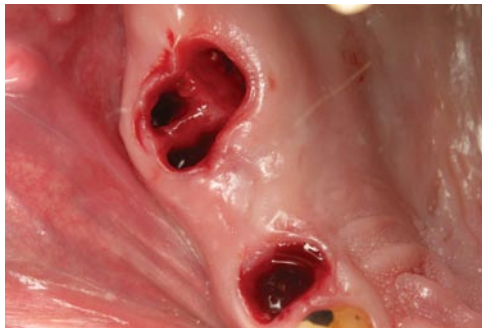
1. Sites #2 and #4, post extraction

A 45 year old female patient was referred by her primary dental provider to evaluate missing and decayed dentition in the posterior maxillary right quadrant. Clinical and radiographic examination demonstrated decay and fracture of tooth #2 (17-FDI two-digit notation) with failed endodontic therapy; region #3 (16) was edentulous; and tooth #4 (15) had a fractured crown with a retained endodontically treated root. The patient had a history of first premolar extractions x 4 with orthodontic treatment as a child. Prior medical history was unremarkable, and the patient is a non-smoker. Under IV sedation and profound local anesthesia, tooth #2 and #4 were extracted carefully without difficulty (Figure 1). Following extraction, access was created through the lateral maxillary sinus wall

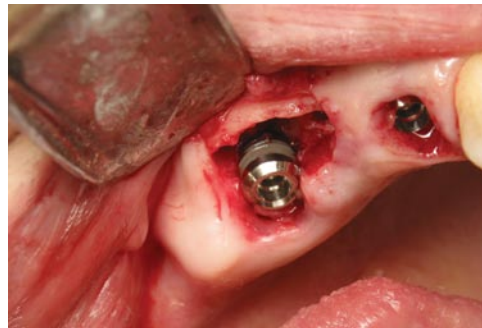
2. Successful Implant Placement at #2 and #4

preserving the integrity of the sinus membrane. The membrane was carefully lifted off the sinus floor. Straumann Standard Plus implants were placed into sites #2 and #4 successfully with nice angulation and orientation and good primary stability (Figure 2). DynaBlast™ (Citagenix Inc., Montreal, Quebec) bone graft substitute was placed around the coronal aspect of the implant in position #2 to fill the void between the socket wall and the implant. DynaBlast was also placed around the implants in positions #2 and #4 where they extended through the maxillary sinus floor (Figure 3). Primary closure was achieved without complication.

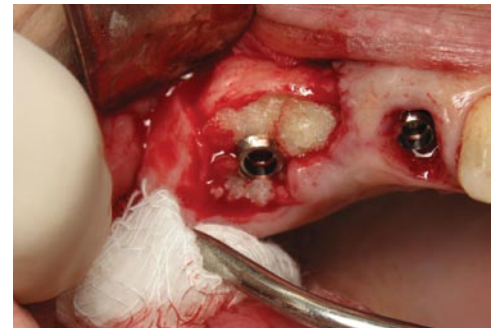
3. DynaBlast placed around implants

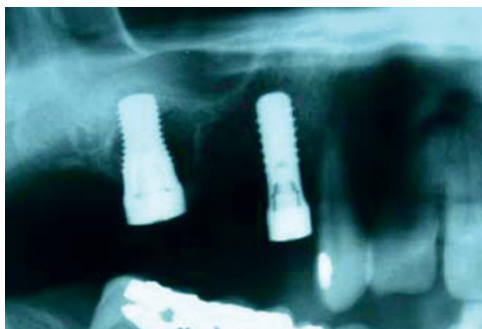
4. Radiograph taken immediately post-surgery with implant and DynaBlast placement

Immediately after implant and DynaBlast placement, a radiograph was taken. With the DynaBlast comprised of demineralized bone, cancellous chips and RPM (reverse phase medium - a bioresorbable carrier that demonstrates increased viscosity with increased temperature), the radiograph ini-

tially demonstrated a radiolucency where the bone graft material was placed (Figure 4). Although there is a mineralized component to the graft material, the site will remain relatively radiolucent. The graft site will increase in radiodensity during healing, thereby providing a radiographic indicator of bone growth. The patient returned after one week without complaints and demonstrated excellent soft tissue healing.

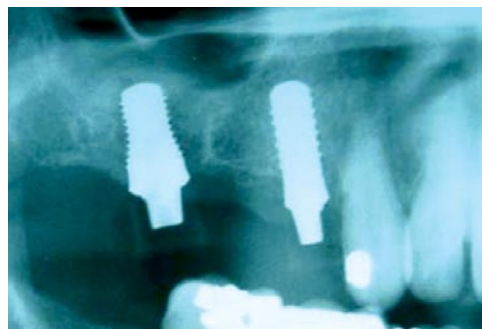
5. Radiograph at 8 weeks demonstrating new bone growth

After 8 weeks, a follow-up visit also demonstrated excellent soft tissue healing. Radiographs showed radiodensity around the implants both coronally and apically, which is consistent with bone regeneration due to the graft material at both implants sites #2 and #4 (Figure 5). Based on the progression of increased opacity of the bone grafted regions representative of bone regeneration over the healing interval, stage two of implant placement was completed with 4 mm solid abutments torqued to 35 Ncm.
